Elite Level Report
456 Sample Drive, Narberth, PA 19072

PROPERTY INSPECTION COVER PAGE

REPORT NO.: 20070225.
DATE OF INSPECTION: 02/13/2007.
TIME OF INSPECTION: 12:00 noon.
CLIENT NAME: Dana King.
INSPECTOR: Simone Cartwright - ASHI #246844.
AGENT/REP: Abraham Williams, Weichert Realtor.
PARTIES PRESENT: Buyer, Buyer's Agent.
HOUSE STATUS: Occupied. This property is occupied with some personal belongings present. The storage of furniture, personal belongings and household goods prevents total and complete review of some areas. A final walk through before closing is recommended.

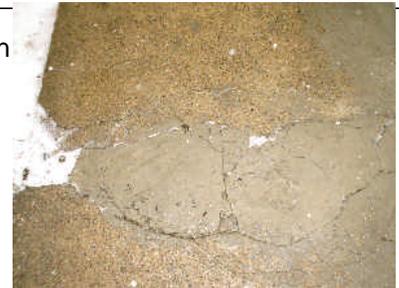
WALKWAYS:

Serviceable. Concrete. Common cracking is present. (Maint.) Heaving is present, which can be a trip hazard. (Maint)(Safety)

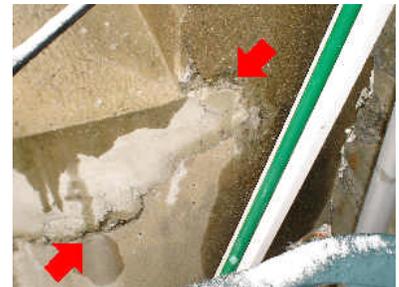
**FRONT STAIRS/
HANDRAILS:**

Serviceable. Concrete. Deteriorated concrete noted at right side of front steps. Recommend repair/sealing to prevent further damage/deterioration and weakening of steps. (Maint.) Handrail is rod iron, Serviceable.

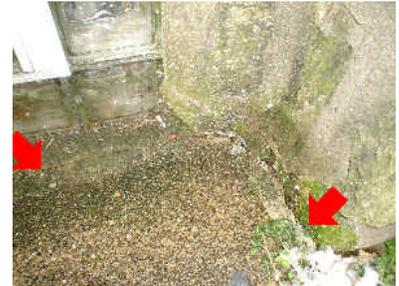
FOUNDATION:

Serviceable. Stone. Common cracks are present at front where the foundation meets the walk way near basement window. No displacement observed. Recommend sealing.

(Notes, Flagged Items and Estimates only given with Abundant's Elite Inspection Report) **NOTE:** The cracks will lead to water penetration at the foundation wall and in the sub area of the house. This is undesirable because it will lead to premature deterioration of building components, wood rot and mold. One way to seal cracks is with hydraulic (water resistant) cement. See foundation page for additional comments.

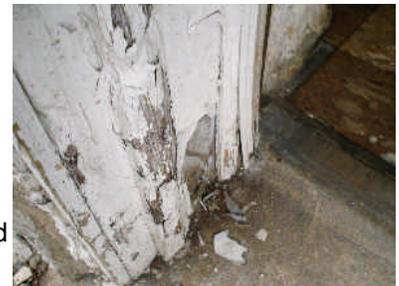
DOORS/TRIM:

Serviceable. Metal door at front. Metal sliding door at dining room to deck. Wood basement door. Wood trim is Weathered at the rear basement door. The paint on wood trim is peeling. This will lead to problems because it exposes the trim to water. Recommend painting. **NOTE:** Paint is a sealant, it protects the wood and when wood gets exposed it could lead to wood rot. **(Maint.)**

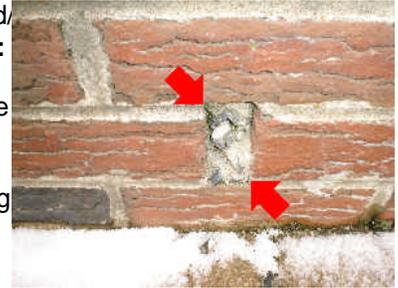
RETAINING WALL(S):

Serviceable. Brick. Drainage holes are blocked/sealed. Recommend unsealing. **Information:** Water is the main cause of retaining wall problems. The soil behind the wall should have no holes or depressions that can hold water. The soil should also come to the top of the wall to allow water to go over the wall. The retaining wall should have drainage holes toward the bottom to allow water to escape. **(Maint)**

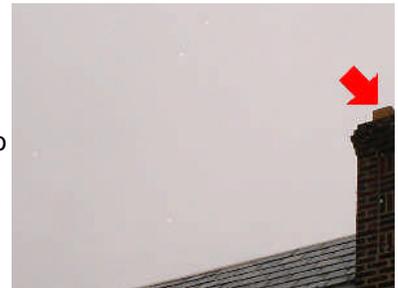
CHIMNEY CONDITION:

Serviceable. Chimney liner does not have a spark arrester/rain cap. Installation is recommended to enhance fire safety, prevent water, rodent and debris penetration. **(Maint.)** Masonry chimney cap was not inspected due to snow. This cap prevents leaks and water penetration to the masonry preventing damage and deterioration to the brick and masonry (the structural part of the chimney) beneath. As preventive maintenance cap should be sealed every one to two years. **(Maint.)** Damage observed to terra cotta liner. **(Maint)(Monitor)**

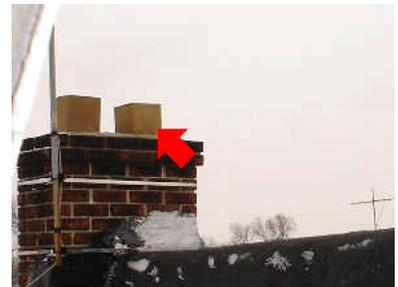
CHIMNEY CONDITION:

Serviceable. Chimney liner does not have a spark arrester rain cap. Installation is recommended to enhance fire safety and prevent water, rodent and debris penetration. **(Maint.)** A crack was observed in the terra cotta liner. Recommend sealing. **(Maint)**

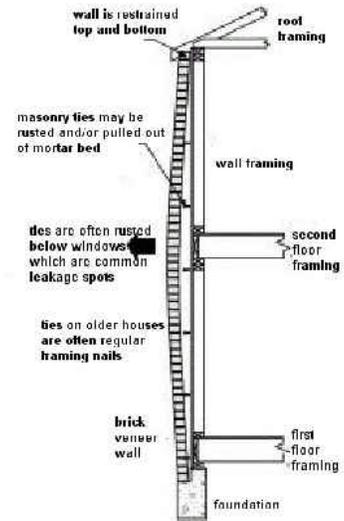
FLOOR JOISTS:

View is limited due to storage and finish. Serviceable were visible EXCEPT: Moisture/ water staining is present beneath the area of the slider doors to the deck and beneath kitchen area where deck is attached. The moisture intrusion is likely caused by the spalling brick observed at the exterior side of the slider door leading to the deck or the attached upper level deck that was added to the property. Stains Tested dry with moisture meter at time of the inspection. Recommend repair/replacement. This type of water damage will lead to deterioration and failure of wood framing if not corrected. *(Maint)(Verify) (Notes, graphics, estimates and flagged items are only available with Abundant's Elite Level Inspection Report)*

View is limited due to shelving, storage and finish. Moisture staining observed at rear wall beneath deck. (see floor joists comments)

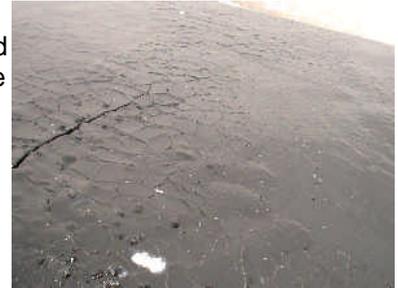
**ROOF
CONDITION**

Roofing materials show signs of age and wear with, blistering and cracking. Maintenance and repair efforts are recommended to preserve the remaining life of the roof. (Maint)

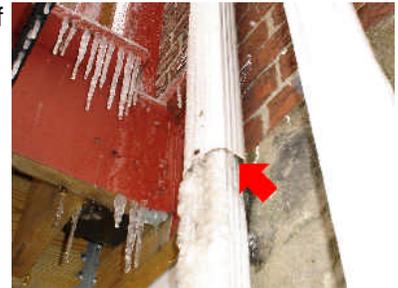
**GUTTERS/
DOWNSPOUTS:**

Gutters are not present at the front. Installing of gutters, downspouts, splash blocks and extensions is recommended to ensure proper drainage away from the foundation. (see foundation wall comments) (Maint.)(Upgrade)
The downspout at the rear is installed incorrectly allowing more water at the base/ foundation of the house. The lower section of the downspout should not be installed on the inside of the upper section, but on the outside. (Maint)

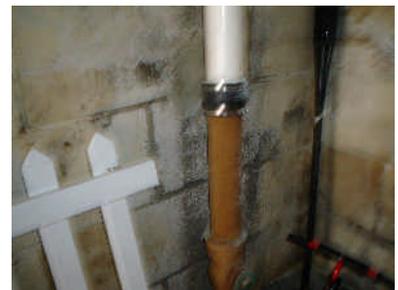
CONDITION:

Rust noted on cast iron pipe in garage. No leaking observed. **(Maint)(Monitor)**

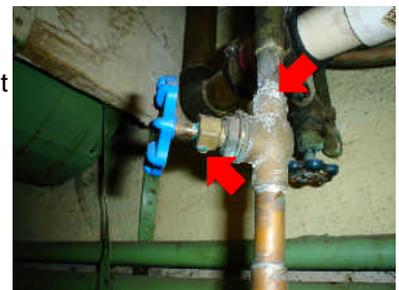
CONDITION: Serviceable. Hot water was obtained at all tested water fixtures. Pressure relief valve noted, not tested. Drain line present. Flue vent intact. A water shutoff valve is installed, some corrosion and leaking observed. (Maint)(Monitor)

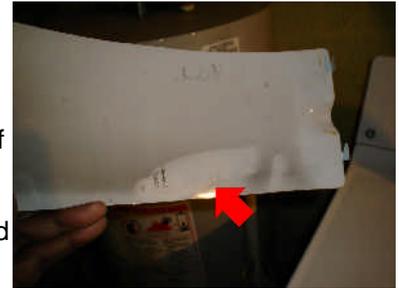
Rust and scale are present in the burner compartment. Cleaning of the burner compartment is recommended. (Maint)(Monitor) Soot is observed around the burner cover/door. This may be an indication of roll out and/or improper combustion may be occurring with this appliance. To enhance safety, a service review for cleaning, tuning and necessary adjustments/repairs is recommended. (Verify)

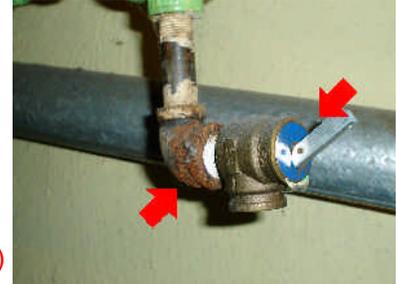
T/P RELIEF VALVE:

Rust and Corrosion observed on Temperature Pressure Relief Valve. Also, as it is presently configured, it appears as though the valve has been activated possibly creating a LIFE/ SAFETY HAZARD. RECOMMEND IMMEDIATE REPAIR/REPLACEMENT by a licensed plumber. Without a properly functioning TPR valve the heating unit has the potential to explode should it overheat. (Safety) *(Notes, estimates and flagged items only available with Abundant's Elite Level Inspection Report)* **NOTE:**

Replacement of TP R valve on this type of system can be approximately \$400.00+ (system may need to be drained of water before replacing valve). Actual cost of repair, replacement, upgrading, maintenance or method of repair vary between contractors, sometimes significantly. Therefore, it is advised that client obtain estimates.

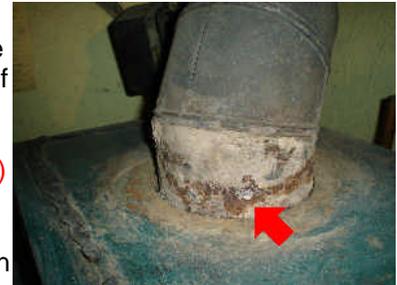
EXHAUST VENTING:

Rust & corrosion are observed on the vent piping. (see carbon monoxide section for more information.) No holes were observed at time of the inspection. Recommend repair or replacement to prevent dangerous gases/ vapors from entering the house. (Maint)(Safety) *(Notes, estimates and flagged items only available with Abundant's Elite Level Inspection Report)* **NOTE:** Flue gases contain moisture and over time the moisture condensates inside the pipe which causes an acidic reaction resulting in rust and corrosion. This can eventually lead to a carbon monoxide leak which is a life threatening health hazard.

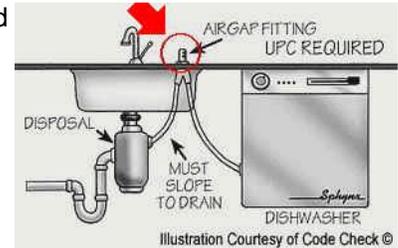
Dishwasher was run during the inspections and appears serviceable. A proper air gap IS NOT installed in the dishwasher drain line. We recommend installing or improving the air-gap device on the drain line. This device helps to prevent cross contamination. **(Upgrade)**

NOTE: The cost of an air gap installation by a qualified plumber may be approximately \$250.00+. Recommend estimates be obtained because contractors prices will vary, sometimes significantly. **(Notes, estimates, graphics and flags are only available with Abundant's Elite Level Inspection Report)**

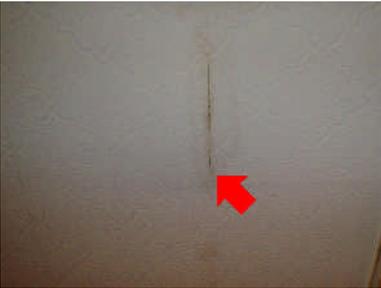
- CEILINGS:** All ceilings are serviceable with the
 EXCEPTION of: Moisture stains observed on ceiling tile in living room at area below bathroom. Stains tested dry with moisture meter at time of inspection. There is no indication that the stains are the result of active leaks. However, active stains only manifest themselves during specific conditions (i.e.during showers with someone in tub). It is unknown how this has affected unseen areas (behind ceiling or under floors coverings). Recommend client confirm from seller if the stains are related to a previously repaired problem or obtain evaluation for source of stains from licensed plumber. (Monitor) (Verify)

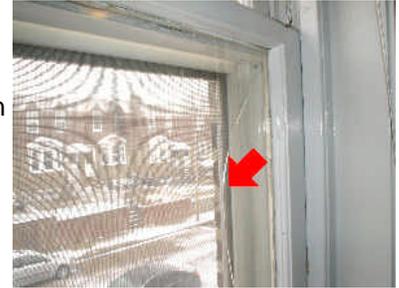
(Maint.)(Safety) Locks at all windows need adjustments. (Maint.)(Safety), Cracked pane observed in:2nd floor front bedroom.

(Maint.)(Verify)
