Elite Level Report
456 Sample Drive, Narberth, PA 19072

PROPERTY INSPECTION COVER PAGE

REPORT NO.: 20070225.
DATE OF INSPECTION: 02/13/2007.
TIME OF INSPECTION: 12:00 noon.
CLIENT NAME: Dana King.
INSPECTOR: Simone Cartwright - ASHI #246844.
AGENT/REP: Abraham Williams, Weichert Realtor.
PARTIES PRESENT: Buyer, Buyer's Agent.
HOUSE STATUS: Occupied. This property is occupied with some personal belongings present. The storage of furniture, personal belongings and household goods prevents total and complete review of some areas. A final walk through before closing is recommended.

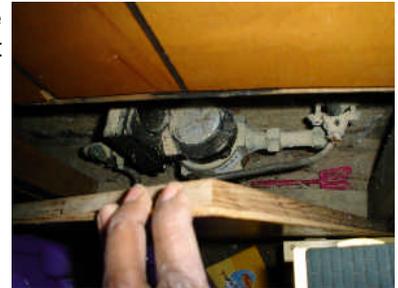
Water supply to this property is provided by the public water system. Copper. Meter located at front of basement.

Appears serviceable, Valve is operational, Valve not tested.

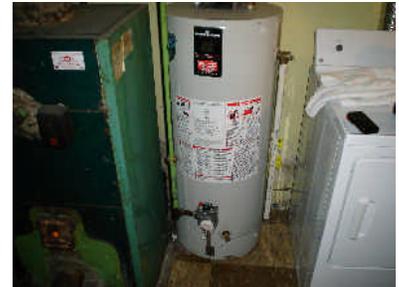
TYPE: Gas.
BRAND: Bradford White.
APPROXIMATE AGE: 5 +/- per ANSI number. (American National Standards Institute)
CAPACITY: 30 Gallons.
LOCATION: Basement.

CONDITION: Serviceable. Hot water was obtained at all tested water fixtures. Pressure relief valve noted, not tested. Drain line present. Flue vent intact. A water shutoff valve is installed, some corrosion and leaking observed. (Maint)(Monitor)

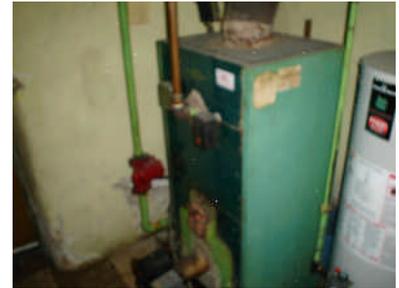
LOCATION: Basement.

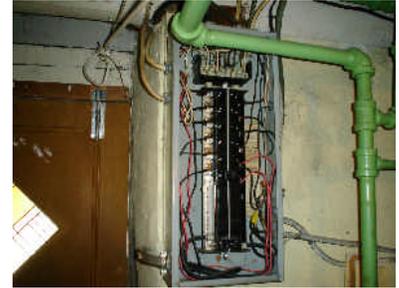
Serviceable. Basement.

Inspector Notes: Grounding system is present.
